RE: *Initial Site Investigation Report,
Wheeler Sports, Lyndonville, VT 98-2509*

INITIAL SITE INVESTIGATION REPORT

WHEELER SPORTS
724 Broad Street
Lyndonville, Vermont

9 March 1999

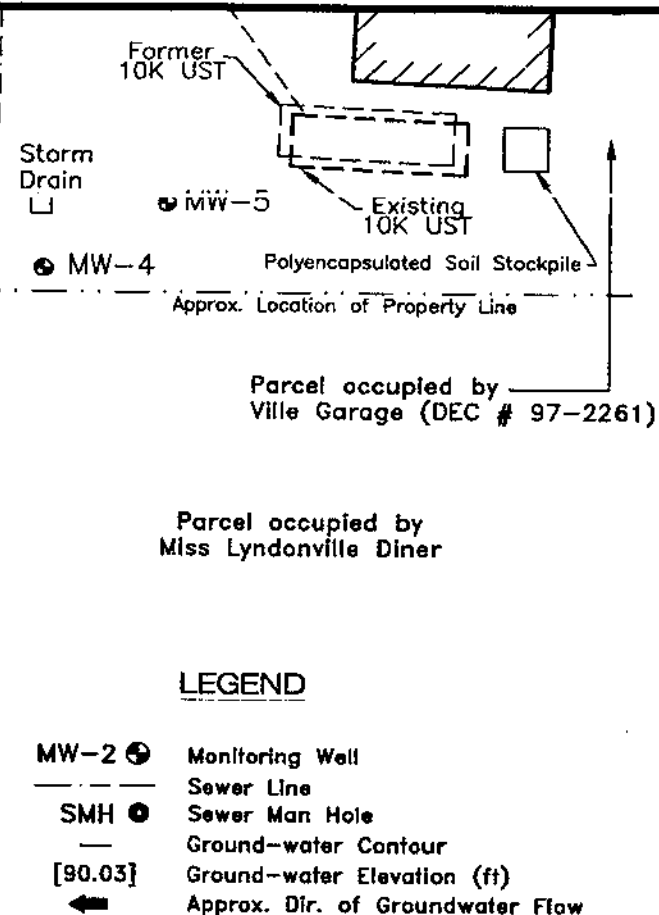
FIGURE 3.
GROUND-WATER CONTOUR MAP
MONITORING DATE: 23 November 1998

Ground water in the unconfined surficial aquifer directly beneath the site appears to be flowing in a northeasterly direction. Regional ground-water flow had originally been interpreted to flow west towards the Passumpsic River, based on topography and ground-water flow directions at the Ville Garage site on the east side of U.S. Route 5. The highly permeable fill material surrounding the municipal utilities, which are within 20 feet to the east of the former USTs, may be influencing the local ground-water flow direction. The average gradient of the local ground-water table on 23 November 1998 was approximately 0.26 percent. Water-level measurements and elevation calculations are

presented in Table 1. The ground-water contour map (Figure 3) was prepared using this data.

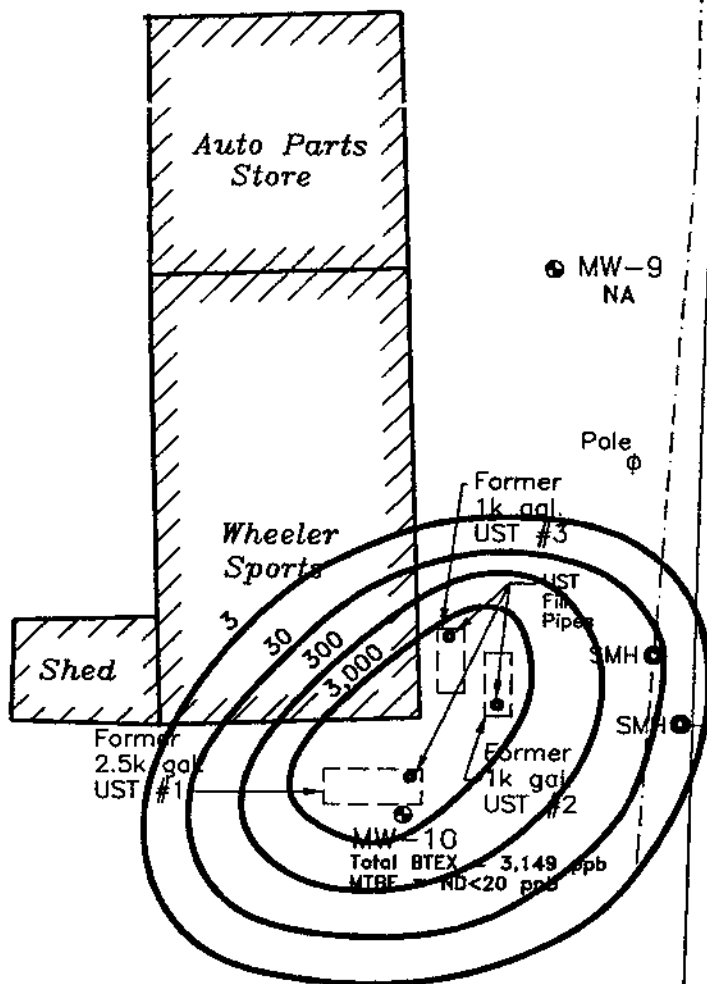
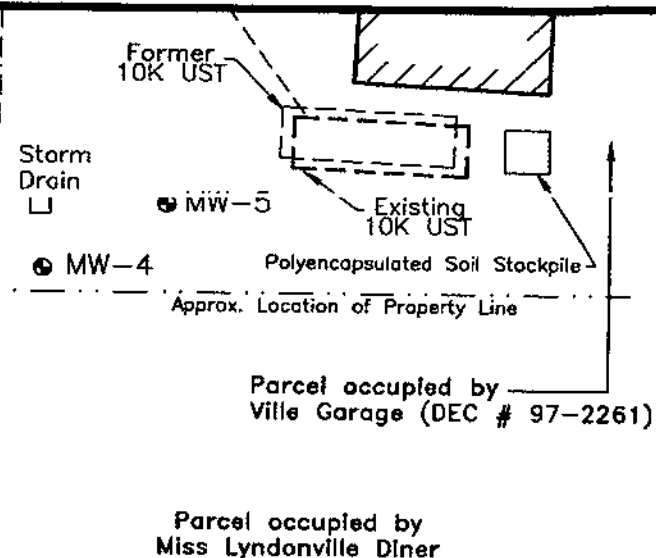
FIGURE 4.
CONTAMINANT DISTRIBUTION MAP
MONITORING DATE: 23 November 1998

reportedly taken out of service, and MTBE was not detected in the ground water sample collected from the immediate vicinity of these USTs. Analytical results are summarized in Table 2, a contaminant distribution map is presented as Figure 4, and laboratory report forms are included in Appendix B.

Vermont Ground-Water Enforcement Standards (VGESs)¹ for volatile petroleum compounds ethyl benzene, 1,3,5-trimethyl benzene, 1,2,4-trimethyl benzene, and naphthalene were exceeded in MW-10. The detection limit for benzene exceeded the VGES at MW-10, due to the presence of high levels of other constituents. The total BTEX concentrations were 3,149 ppb. No volatile petroleum hydrocarbons were detected in the samples collected from MW-11 or MW-12, presumably because the wells are actually upgradient of the on-site USTs.

● MW-12
Total BTEX = ND<1 ppb
MTBE = ND<1 ppb

● MW-11
Total BTEX = ND<1 ppb
MTBE = ND<1 ppb

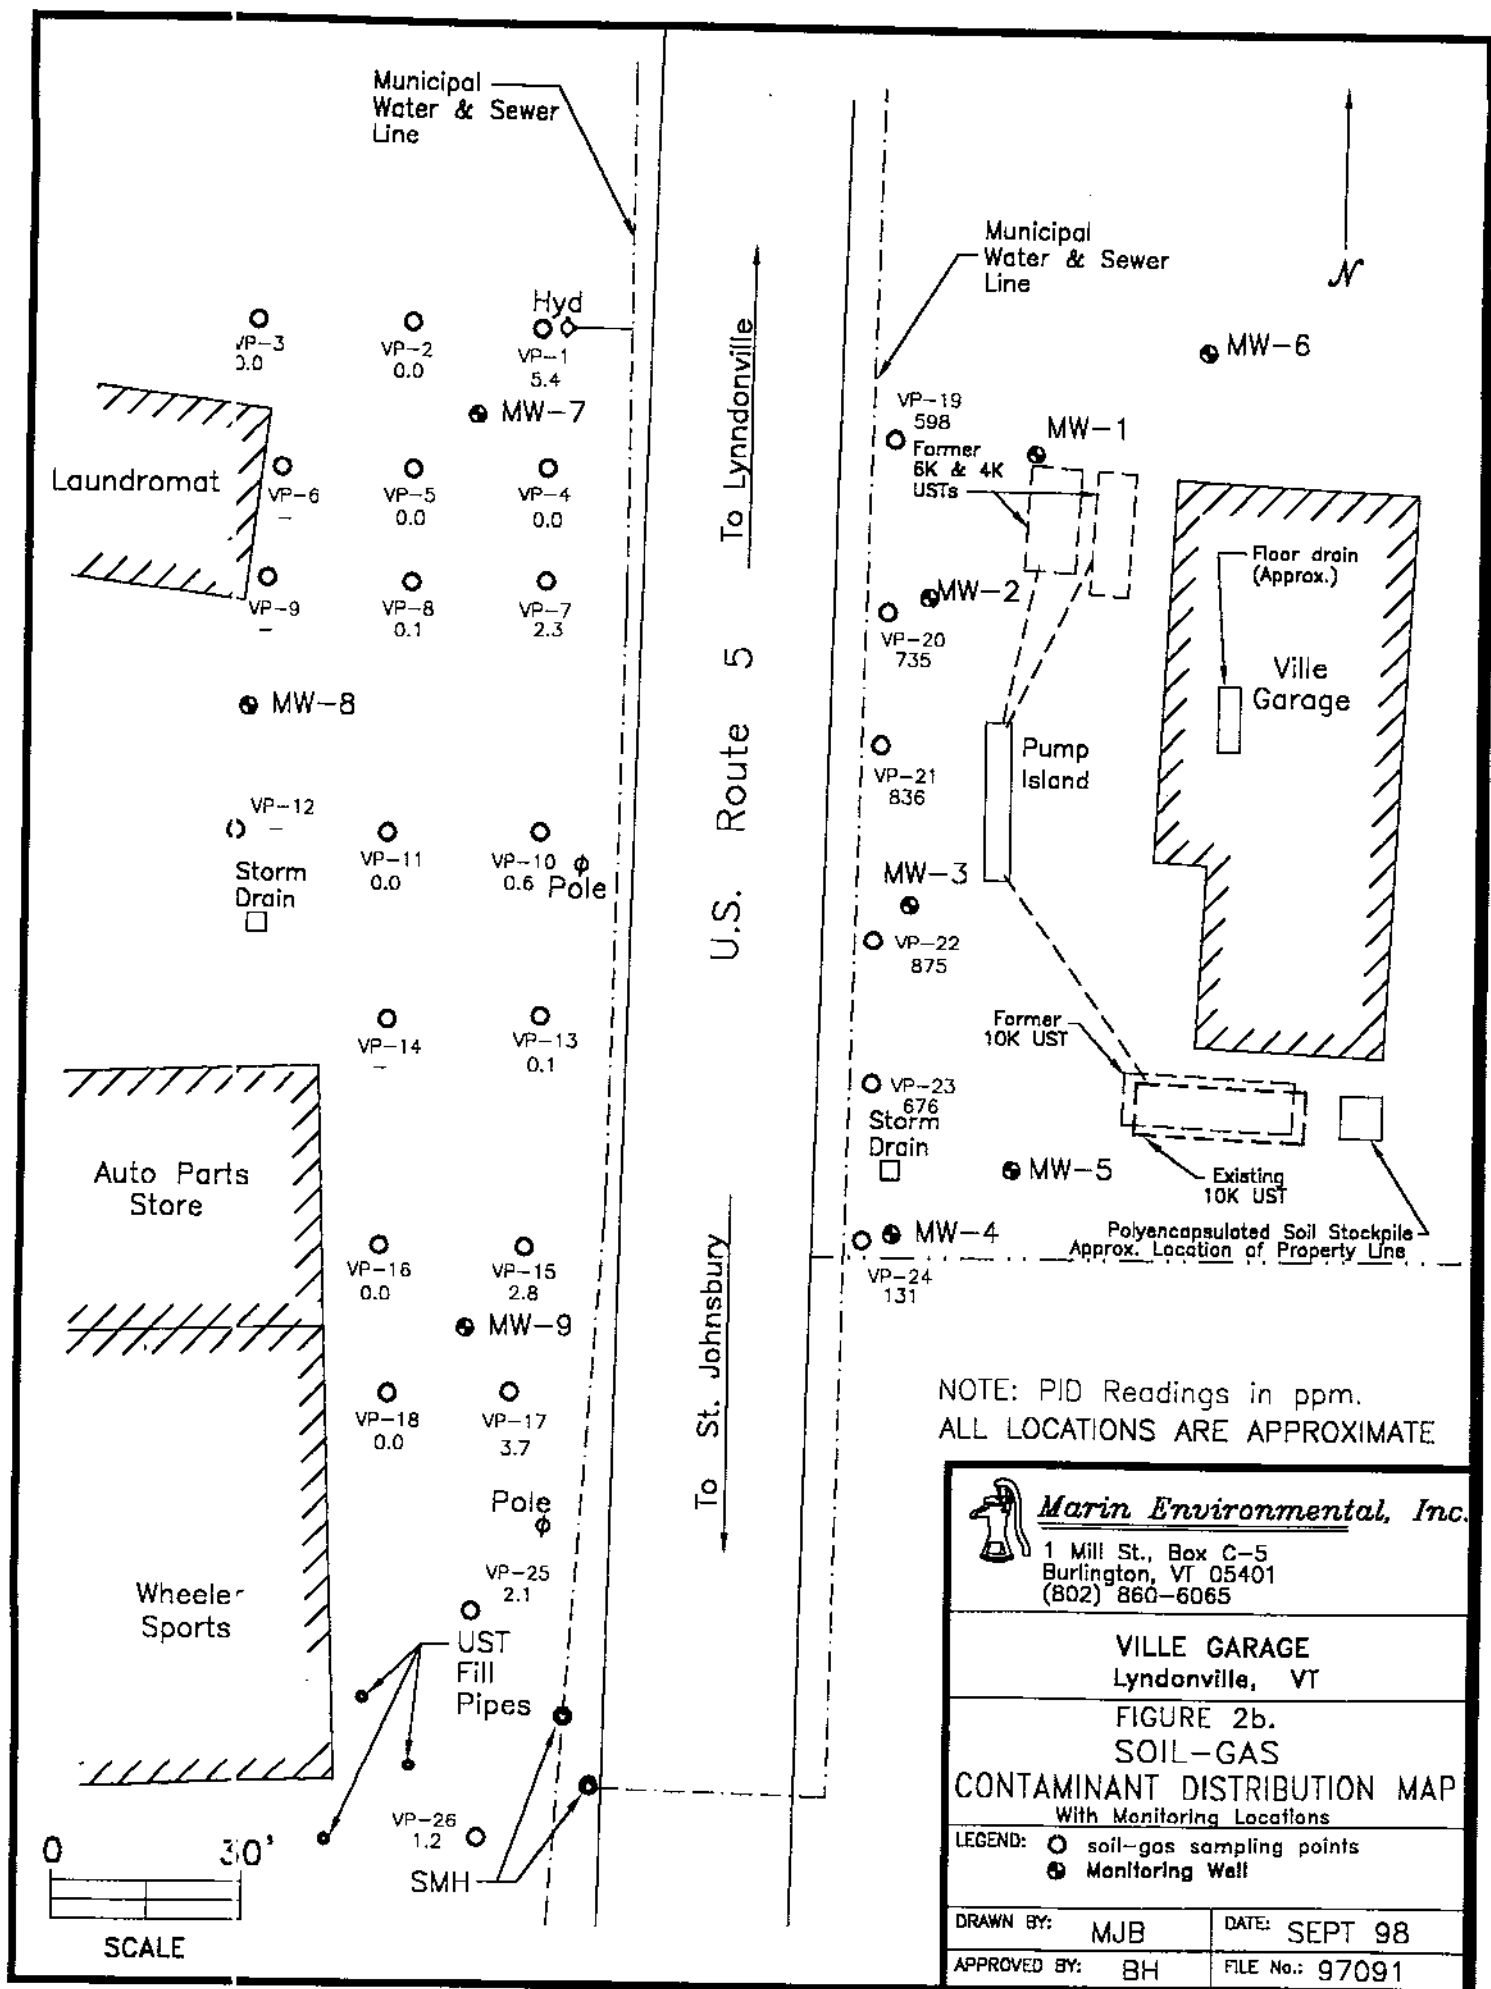
Soil-Gas Survey Results - Ville Garage Site

- The risk of vapor entry into water and sewer manholes has not been adequately evaluated as part of this study. However, as part of **Marin's** investigation of the Ville Garage, a soil gas survey was performed. The survey included the area between the former USTs and the utility lines. Slightly elevated PID readings (1.2 to 3.7) were measured in this area. A summary of this data is shown on a figure provided as Appendix C, from the Ville Garage investigation report.

- A soil-gas survey performed by **Marin** as part of the Ville Garage investigation extended to the area between the subject parcel's former UST location and the utility lines. Slightly elevated PID readings (1.2 to 3.7) were measured in this area.
